LITTLE DIXIE DAM
CALLAWAY COUNTY, MISSOURI
MO 10888

⑥ PHASE I INSPECTION REPORT
NATIONAL DAM SAFETY PROGRAM.

LITTLE DIXIE DAM
CALLAWAY COUNTY, MISSOURI
MISSOURI INVENTORY NO. 10888

Name of Dam: Little Dixie Dam
State Located: Missouri
County Located: Callaway County
Stream: Owl Creek
Date of Inspection: 23 August 1978

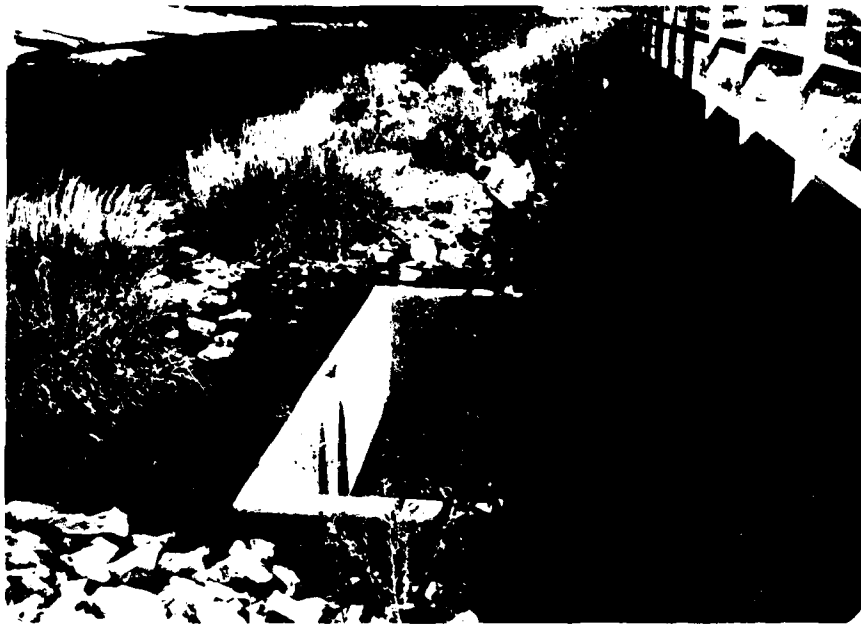
Three vertical cracks were evident in the weir wall of the intake structure. Two of the cracks were leaking slightly. Also leaking was the lower portion of the joint where the weir wall meets the abutment of the bridge which spans the chute spillway.

Primary Spillway Inlet Structure

The cracks in the weir walls should be sealed to prevent future deterioration due to freeze-thaw conditions. The bridge over the primary chute spillway should be checked by a structural engineer to assure its adequacy. Necessary repairs can subsequently be made.

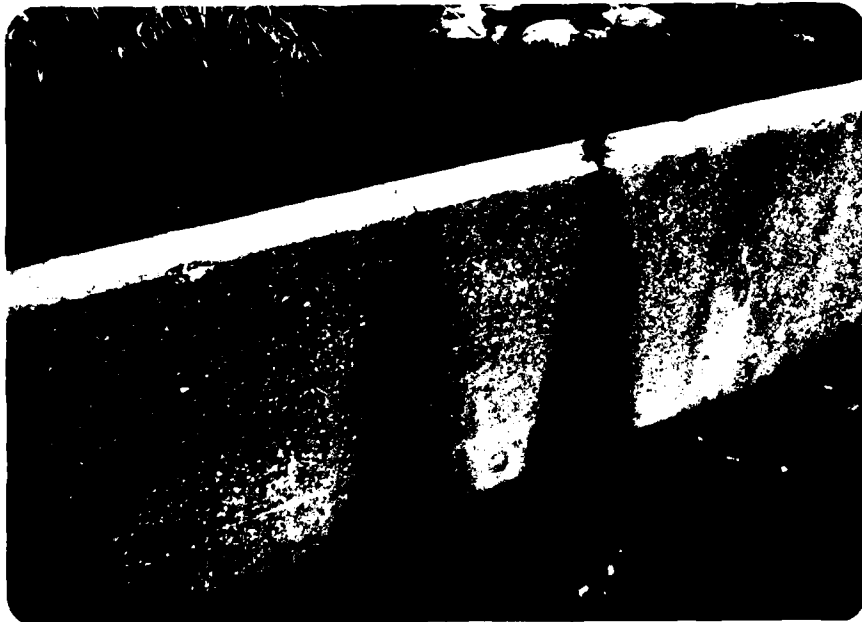
The weir walls in the inlet structure of the primary spillway are cracked and leaking. The concrete chute spillway appears to be in good condition. The earth-and grass-covered emergency spillway is in good condition. The emergency spillway has apparently never been used.

Cracking in Primary Inlet Weir Walls

- (2) Seal the cracks in the weir walls and the joints at the weir wall and bridge abutment contacts.
- (3) Correct the minor erosion activity on the dam side of the chute spillway exit.

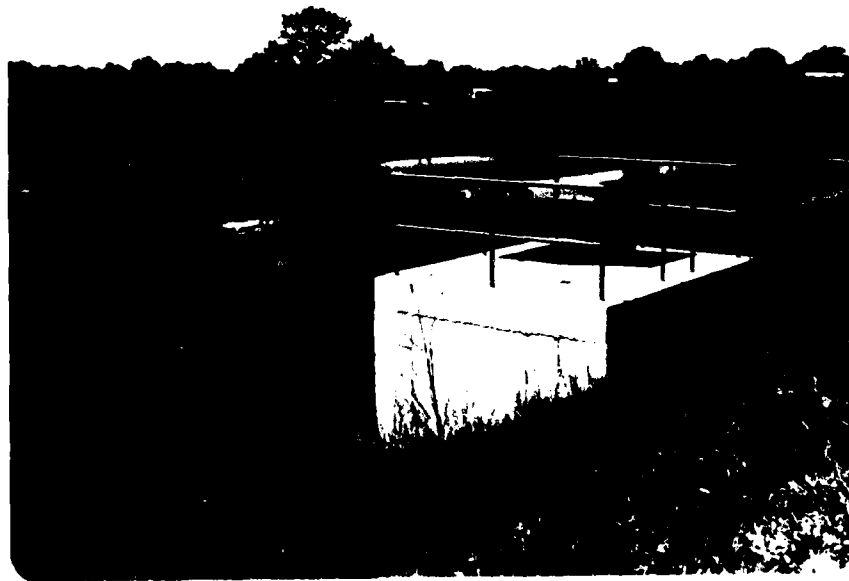
Rearing Pool Feed Line Gate Valve

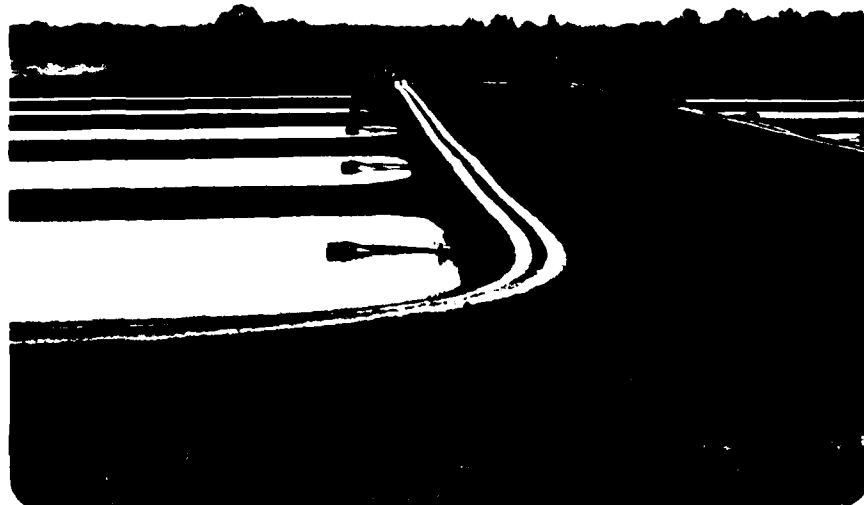
Fish Rearing Ponds - Looking Downstream
